A Review of Champion Spark Plug Insulator Cracking Issues In TCM Engines

Synopsis

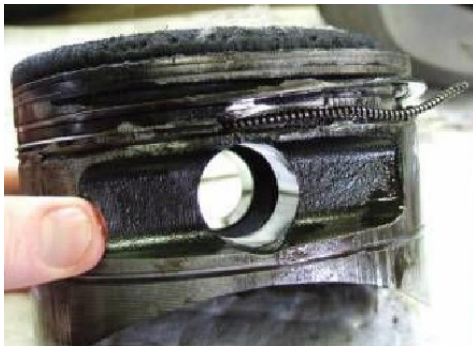
Piston photo from TATI SB11-05

The photo evidence in the MSBs are much more indicative of detonation than pre-ignition. The photographs in the MSBs show a piston that has a pock marked crown, broken ring lands and a scuffed skirt. This is what one would expect from detonation damage; pre-ignition would result in a hole melted in the piston and little scuffing or land damage. Below are photos from TATI, Hastings (a well known piston ring maker) and from the Mahle piston damage book. Although it can be difficult at times to discern the difference in detonation and pre-ignition damage because each can occur or cause the other, it is clear from the photo's that the TATI piston is largely detonation damage. The TATI piston shows the pocked crown that is illustrated by Mahle Figure 3.7-1 and scuffed skirt characteristic of detonation damage that is shown in Mahle Figure 1-3. There is little resemblance between the TATI photo and Hastings and Mahle Pre-Ignition Damage photos.

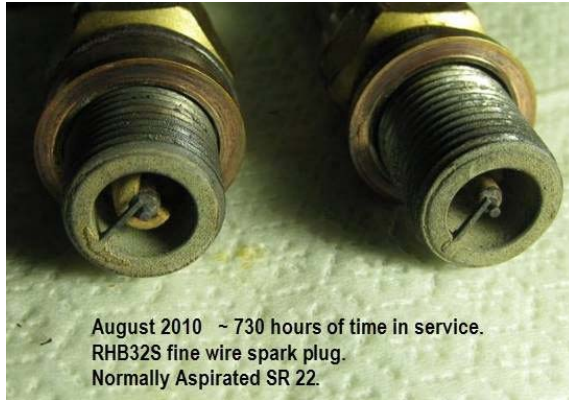
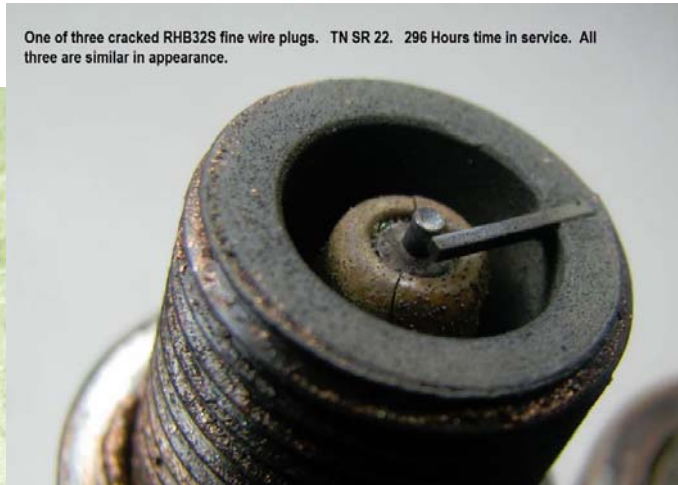
The spark plugs in the MSB photographs also show the characteristics expected from detonation damage, that is; broken insulators. Pre ignition damaged plugs will have the center and ground electrode melted.

Photos from TATI SB11-05, photo on the left is from a naturally aspirated SR22 and the one on the right is from a turbo-normalized SR22.

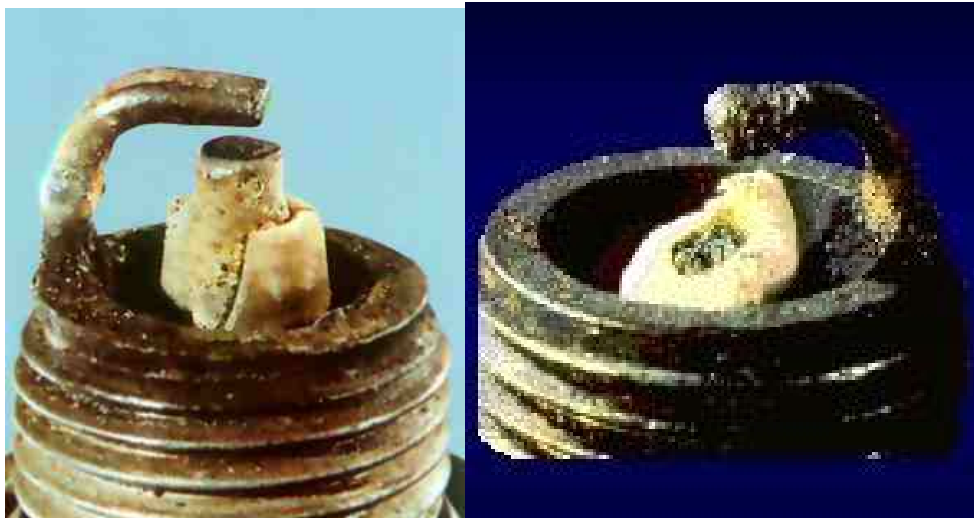
Photos of damaged automotive spark plugs, left plug is detonation, right plug is pre-ignition damage. (photo's from Champion)

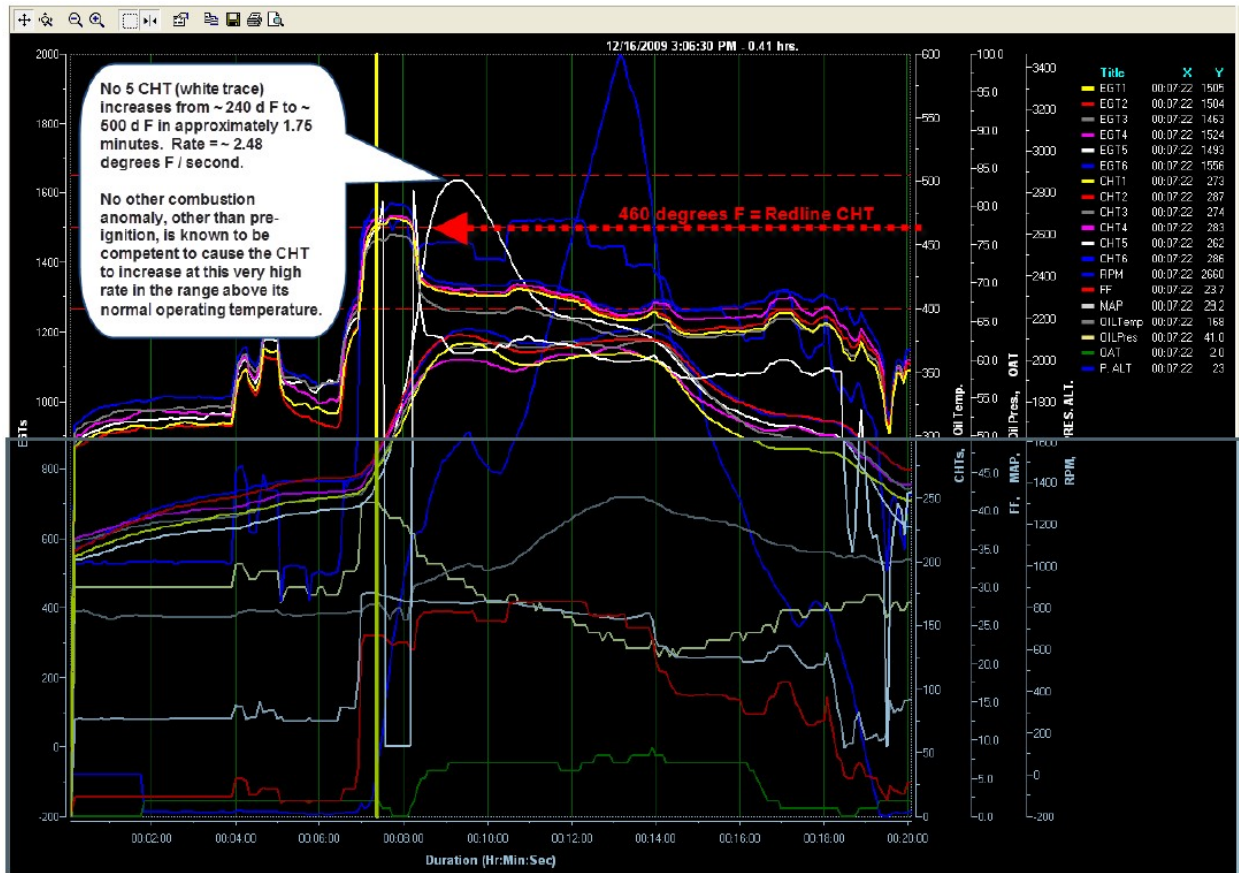
Data Download for NA SR22 from TATI MSB 11-05

So, what is causing the issues resulting in the TATI MSBs? There is good evidence in the data download given in the MSBs that at least the engine of the download was being operated in a condition that reduces the detonation resistance of the engine. The data download given is from a naturally aspirated SR22, again a curious choice for a SB intended for turbo-normalized engines. The MSB download chart is given below. The download shows a fuel flow of approximately 23 gph and assuming that the engine is producing 310 bhp, the specific fuel consumption would be .44 lb/bhp/ hour. This sfc is fairly close to best power and far from the .52 sfc that is the target 27.1 gph fuel flow in the SR22 POH. It is likely that the engine was developing more that 310 bhp since the download shows a pressure altitude of -200 feet and an OAT of less than zero at takeoff when the event occurred. The increased power will be in the range of 10% or 340 bhp, with a resulting sfc of .40 lb/bhp/hr, pretty close to peak EGT and certainly in the operation zone where detonation resistance is lowest. In short, the engine was not operated according to the POH, that it was probably leaned for takeoff, and that it was detonation that caused the cylinder failure.
